Assessing Shoreline Recession Rate for Lake Ontario

By: Brittney Bishop & Jayson Ruth

GEOG 4030 – 2016

The purpose of this report is to compare GPS and aerial photography methods for assessing shoreline recession rates for the bluffs of Lake Ontario.

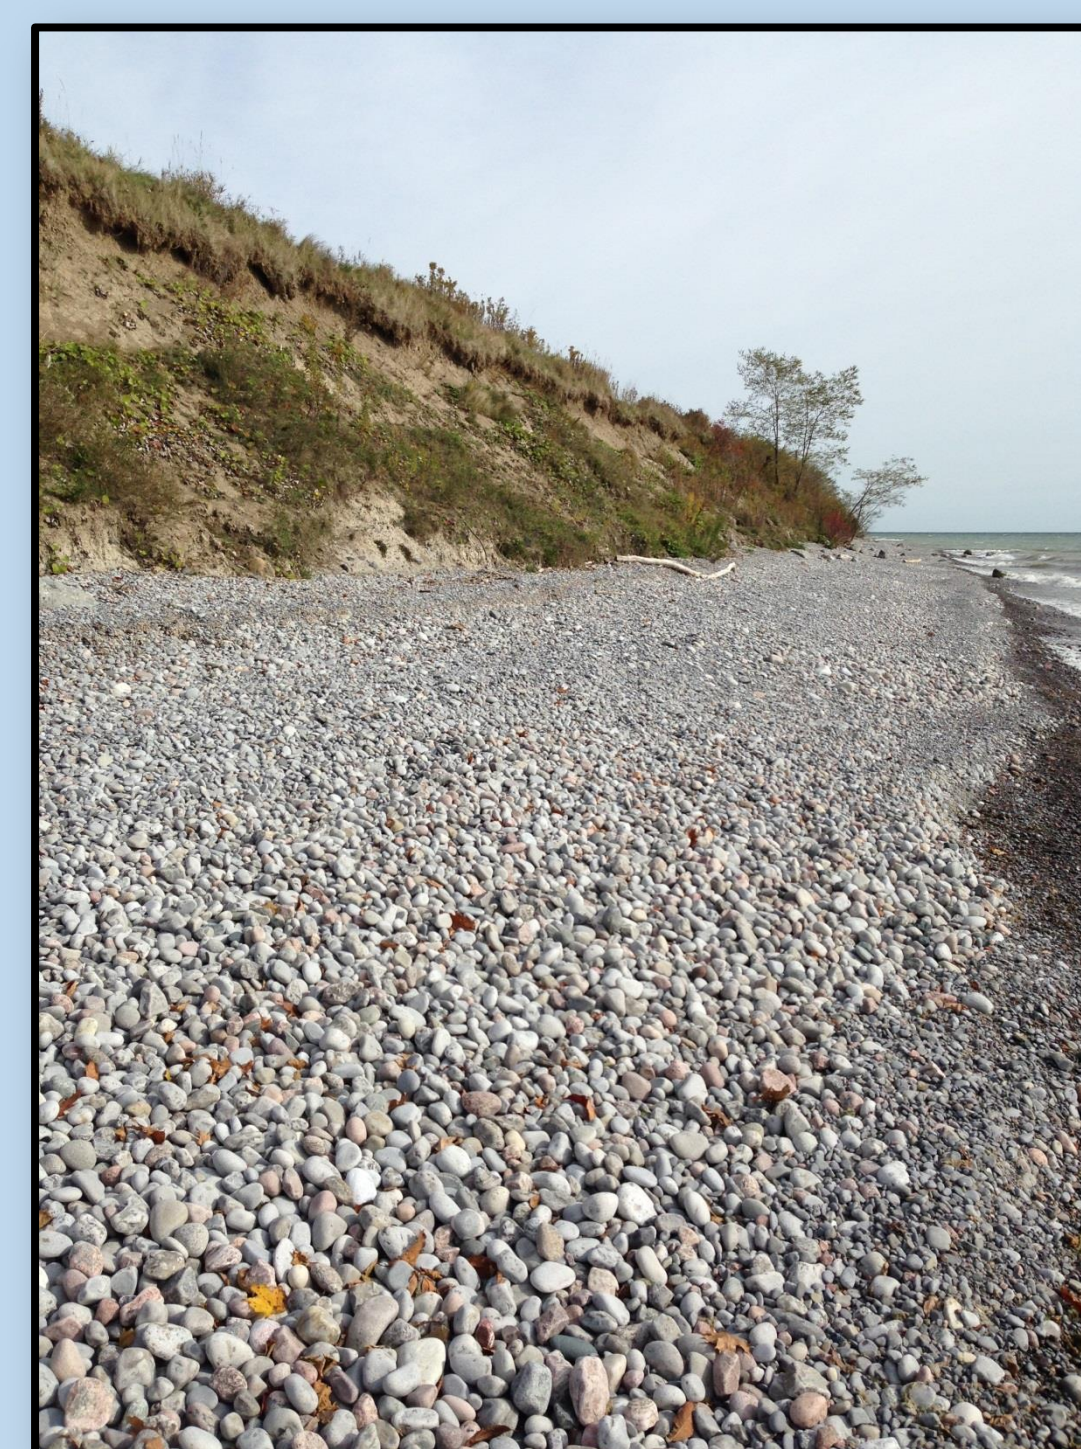
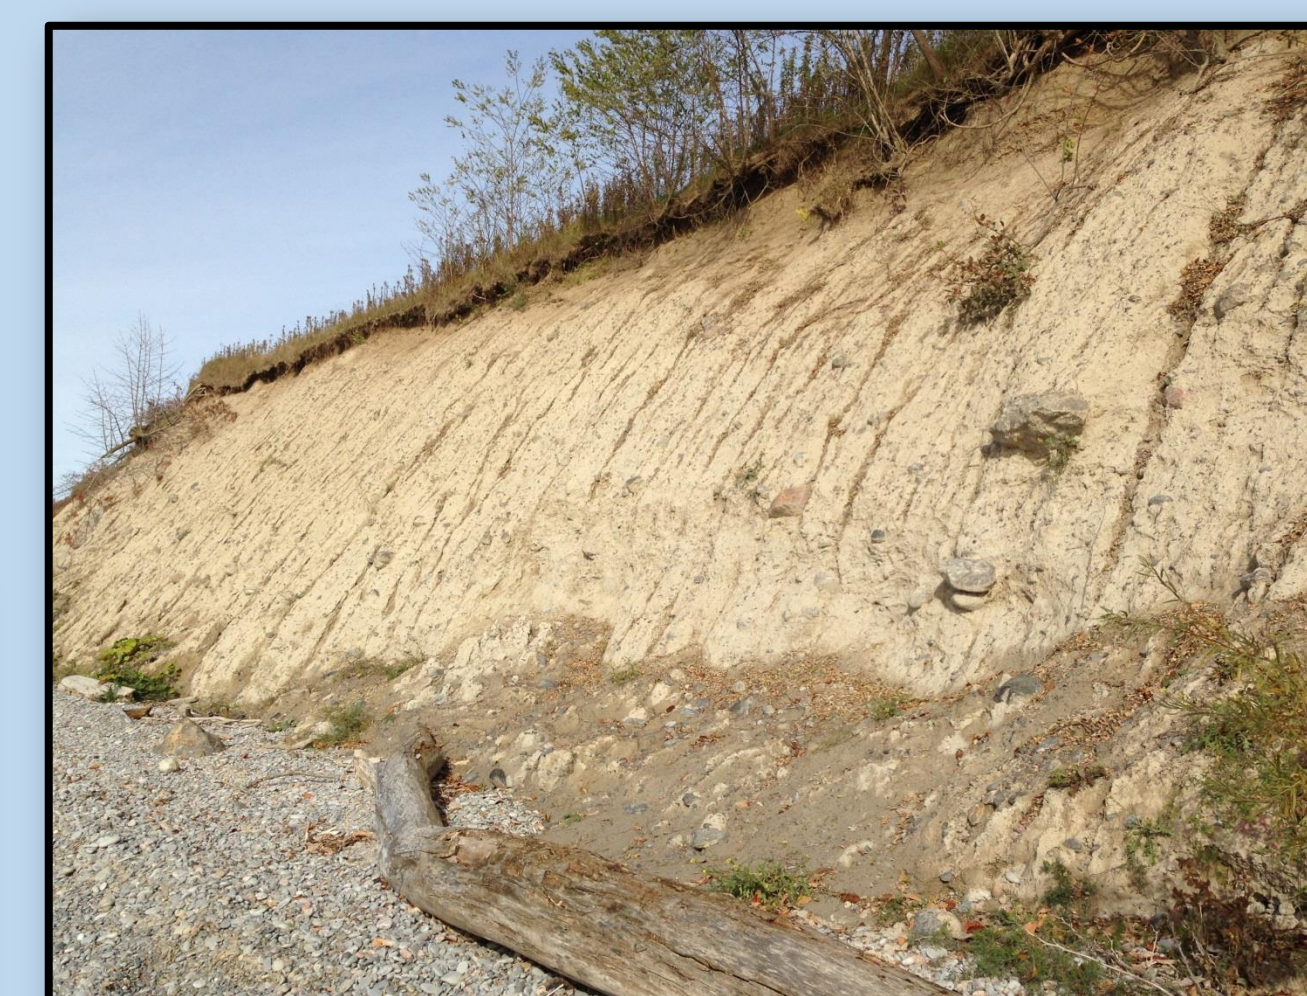
Figure 2: Site 1 (top right), Site 2(left) and Site 3 (bottom right)

The main mandate of the Ganaraska Region Conservation Authority is to monitor, conserve, restore and manage water, land and natural habitats through programs within 7 municipalities. The research done for this report will be part of a four part shoreline management plan. This report will be used in the natural hazards section of this plan. This research is important not only for the management plan but will also be used to determine the accuracy of equipment to assess shoreline recession rates. The research resulted in an average annual shoreline recession rate for a section of Lake Ontario. Figure 1 below displays this section of Lake Ontario. This information will be used to inform land owners of the environmental effects of shoreline recession. Figure 2 displays a photo of each of the sites visited for this report.
